Recovery of Container Glass At Material Recovery Facilities

**Resource Management
Companies**

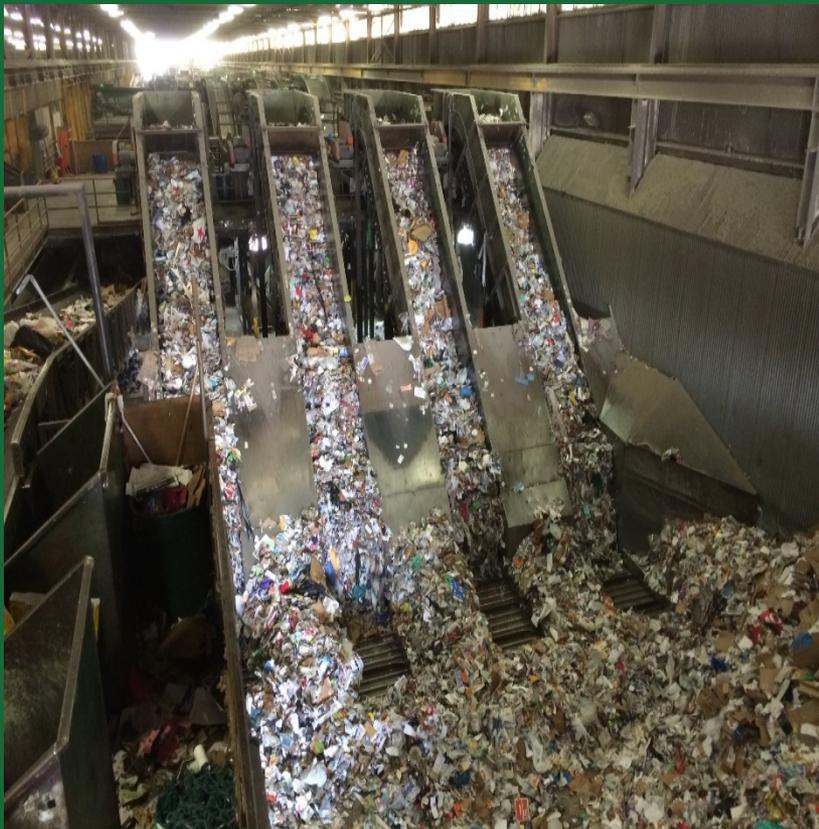
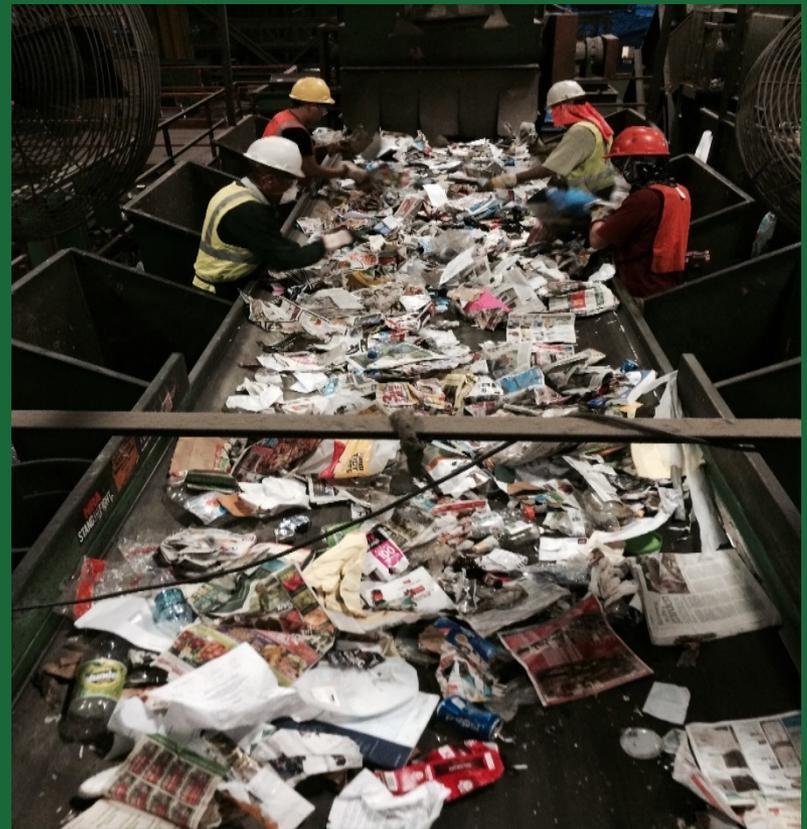
Residential Single Stream Mixed Broken Glass

Glass camouflaged by larger size material

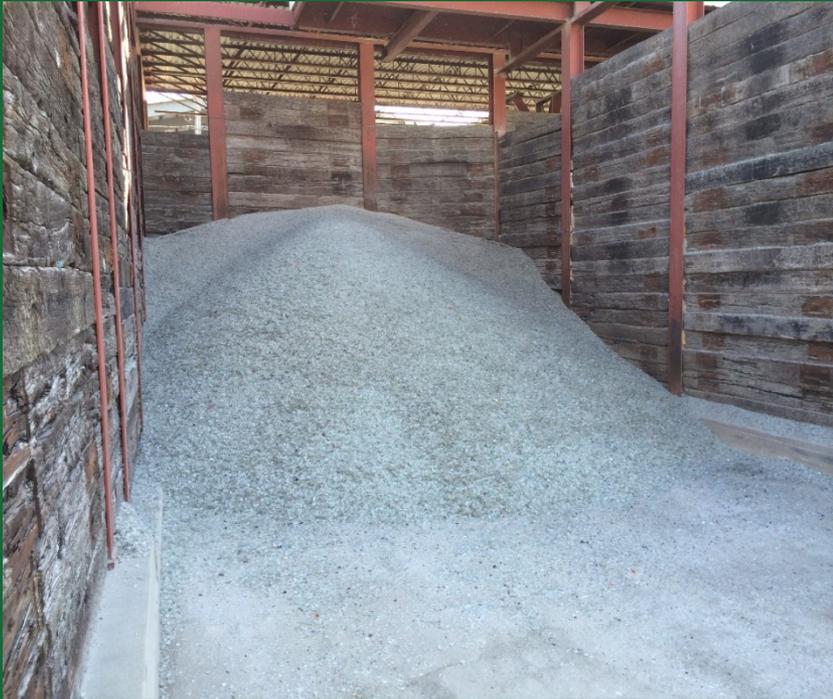
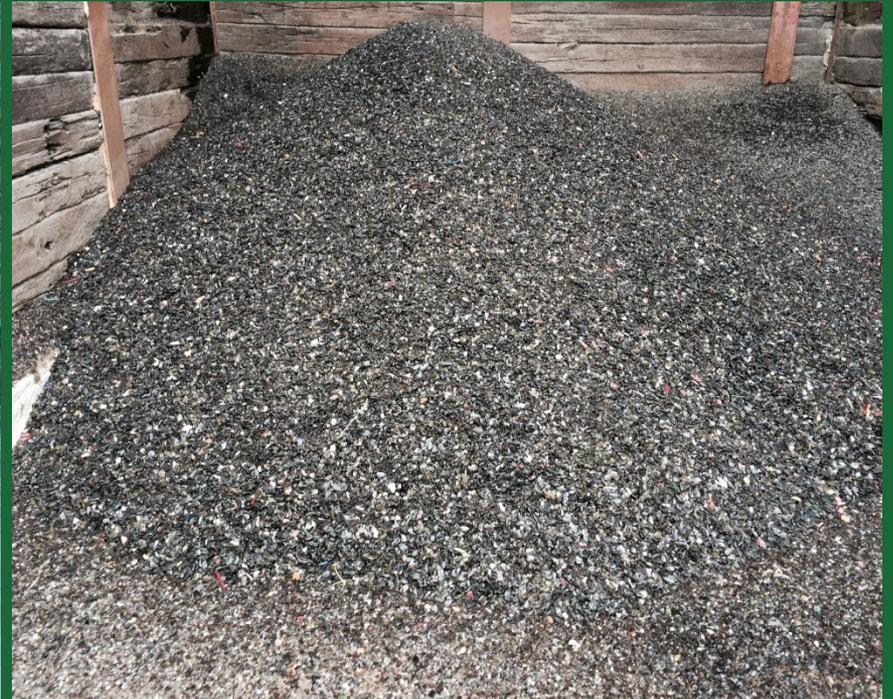
Current Markets for RMC Cullet

Furnace ready bottle cullet for sale to bottle plants

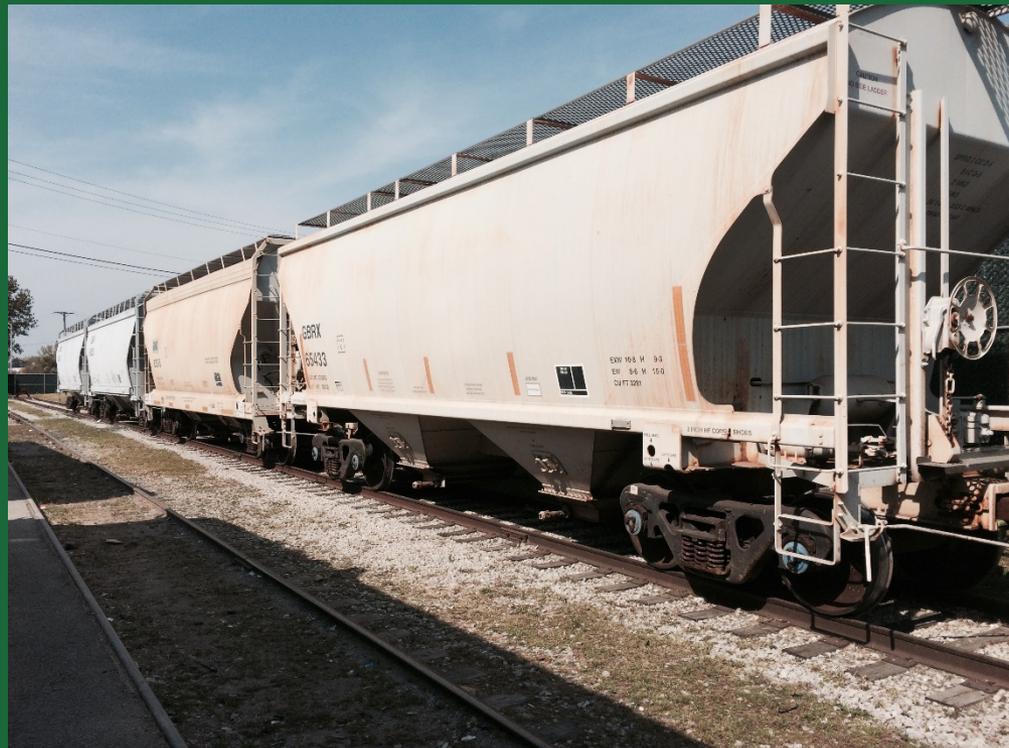
Current Markets for RMC Cullet

Minus 12 mesh finely ground cullet for sale to insulation manufacturers

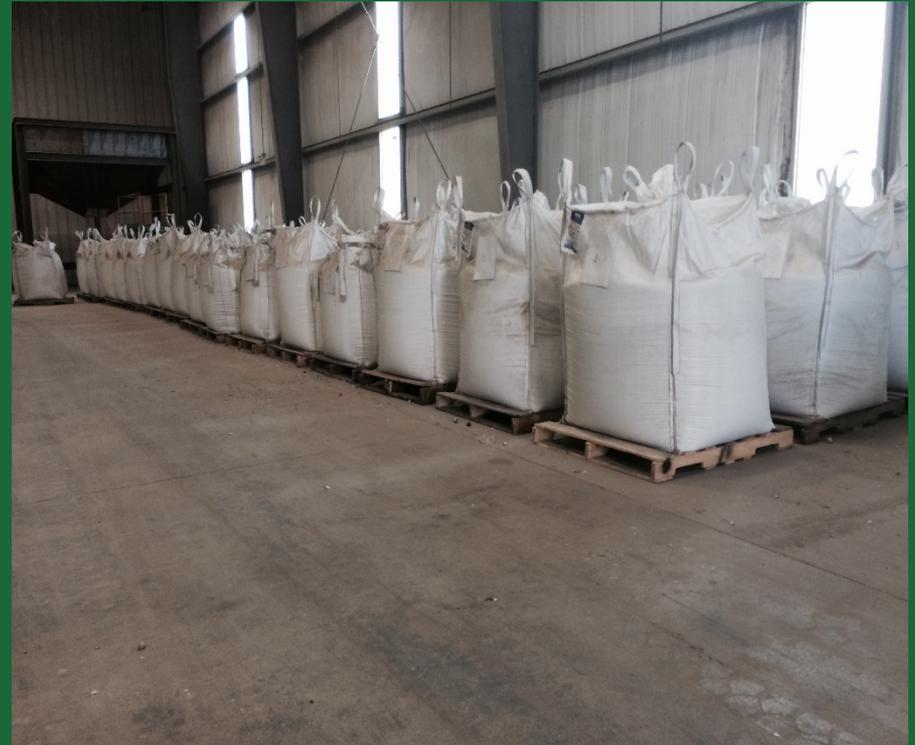
Current Markets for RMC Cullet

Finely ground and screened cullet for sale to sandblast media distributors

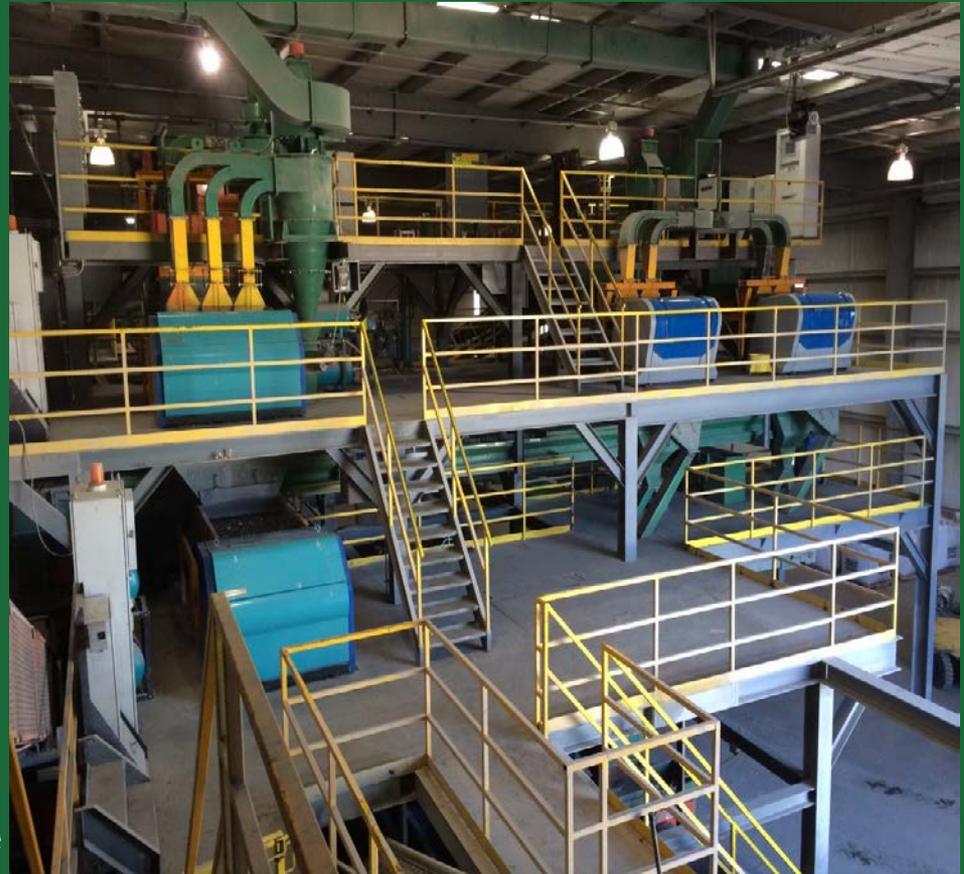
Processing Glass in a MRF Setting: Optical Sorting Challenges

Capital intensive

- Need high volume

Costly to maintain

- Glass is abrasive

Demanding specs

- Ceramics intolerance

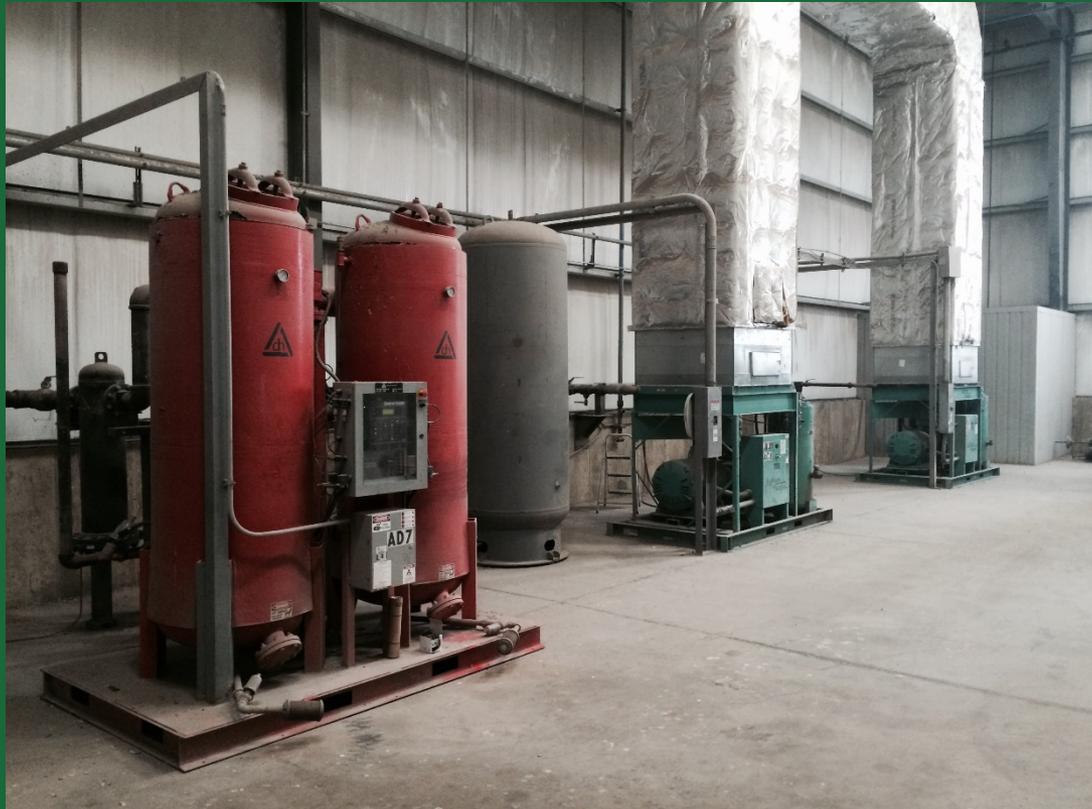
Processing Glass in a MRF Setting: Operating Cost Challenges

Energy intensive (Gas and Electricity)
